Manhole Inspection Summary

Manhole # S270__002MH

Insp Date: **4/30/08 12:35 PM**

Location Address: **1146 W Ostend St**

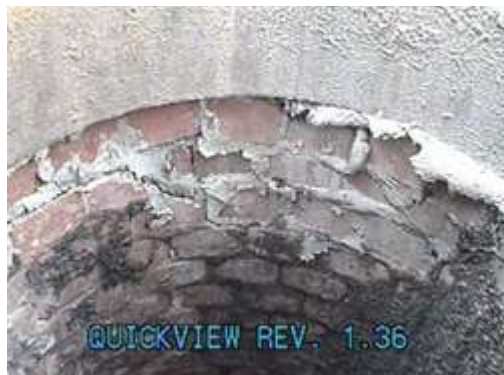
Defect 4

Condition: ☐ Sound ☒ **Cracked** ☐ Root Intrusion ☐ Loose Brick ☒ **Deteriorated**

Condition: ☐ Sound ☒ **Cracked** ☐ Root Intrusion ☐ Loose Brick ☐ Deteriorated

Cracked and Deteriorating Chimney,
Cracks in Corbel

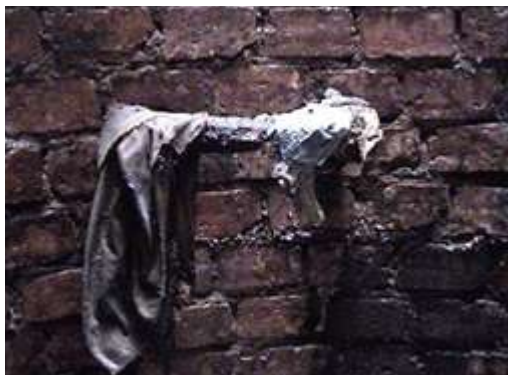
Defect 3

☒ **Evidence Of Surcharge** Depth: **6** (ft.) ☐ Active Surcharge Present

SIGNS OF SURCHARGE

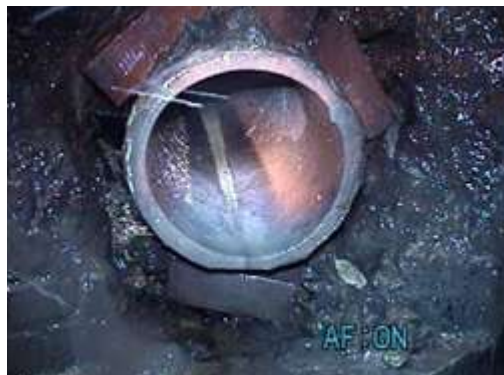
Defect 5

Condition: ☐ Sound ☒ **Cracked** ☐ Root Intrusion ☐ Loose Brick ☐ Deteriorated

Infiltration: ☐ None ☐ Joint ☐ Cracks ☒ **Mortar** ☐ Roots ☒ **Wall**

Barrel infiltration, cracks in barrel

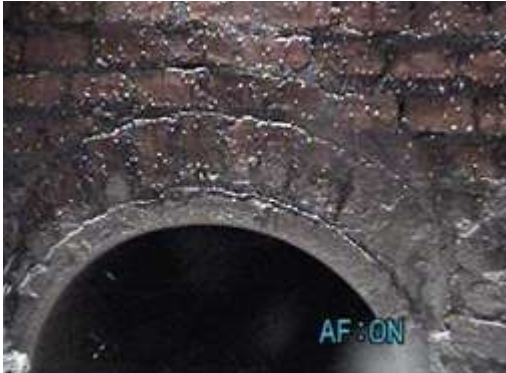
Defect

BARREL INFILTRATION ABOVE
12O'CLOCK PIPE.

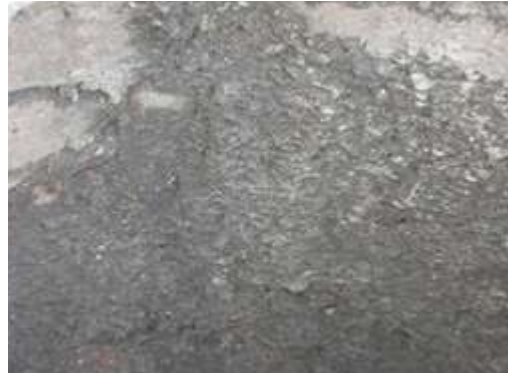
Defect 2

Infiltration: ☐ None ☐ Joint ☐ Cracks ☐ Mortar ☐ Roots ☒ **Wall**

SIGNS OF INFILTRATION CORBEL

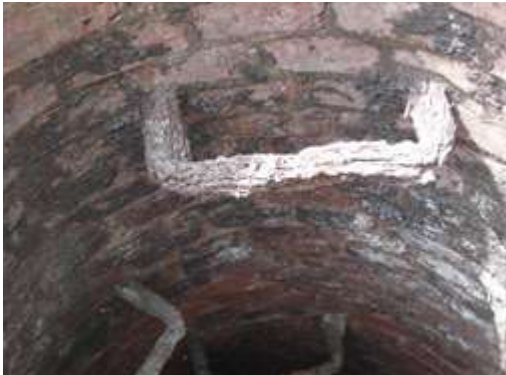
Defect 1

Count: **10** Missing: **0** ☒ **Corroded**

RUSTED RUNGS SIGNS OF
INFILTRATION AT CORBEL.

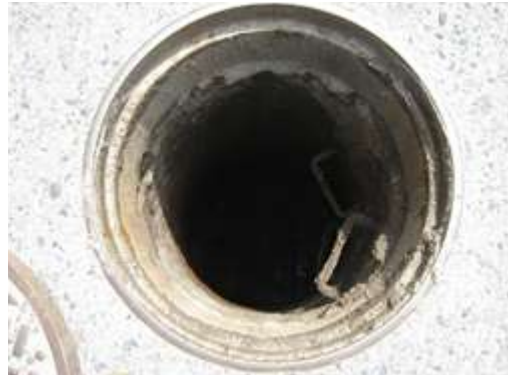
Defect

Condition: ☐ Sound ☐ Cracked ☒ **Leaks**

frame leaks

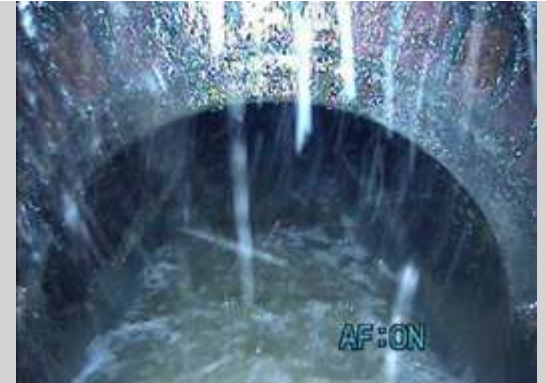
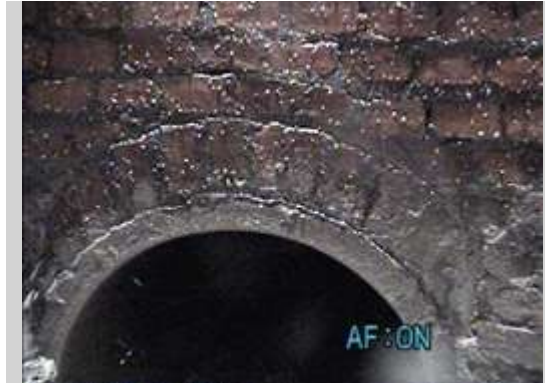
12 O'Clock Outflow

BARREL INFILTRATION ABOVE 12OCLOCK PIPE.

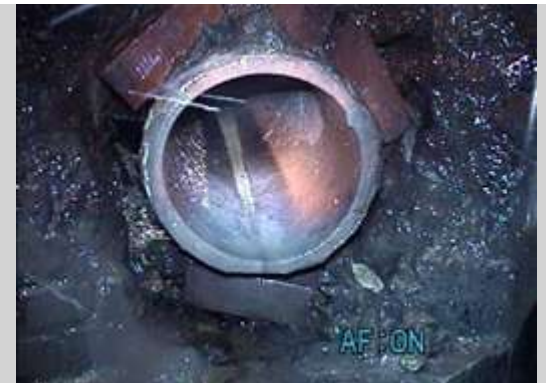
5 O'Clock Inflow

SIGNS OF INFILTRATION MISSING
MORTAR/UNKOWN CONNECTION (COULD
BE AN ILLEGAL CONNECTION)

Pipe Height: **9.6** (in.) Rod and Bar (Angled)
Pipe Material: **Clay** ☐ Pipe Lined
Invert Depth: **14.83** (ft.) Flow Characteristics: **None**
Deposits: ☒ None ☐ Mud ☐ Sludge ☐ Debris ☐ Grease
Silt Depth: **0** (in.) Deposits Extent:
Infiltration: **Evidence** Pipe Seal Cond: **Broken**
